Case Study – FFP Assessment, Vessels.

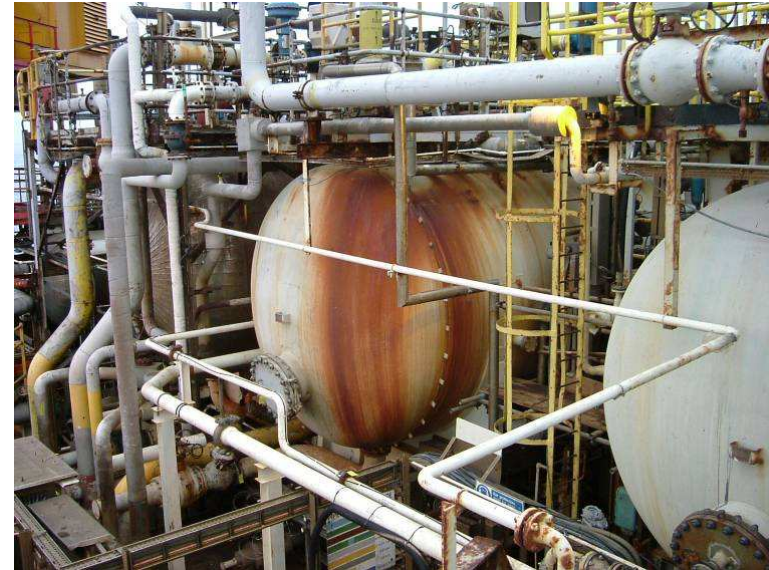
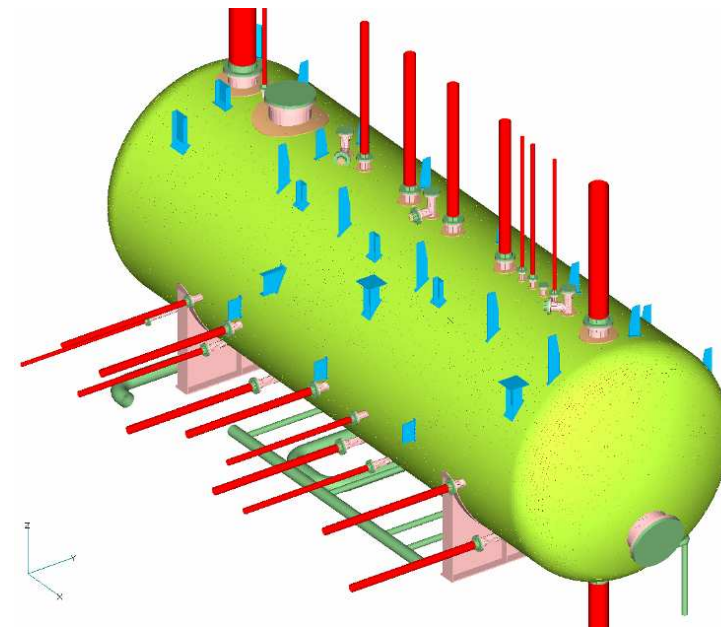
- Under-Insulation Corrosion on High Pressure Separator
- Combined loading on vessel (pressure, pipework, walkways, etc.)

- Separator shown to be fit-for-purpose
- Technical basis for scheduling future maintenance & repair.
